ARMY RESEARCH LABORATORY

T-55 Engine Compressor Stator Vane Investigation

ARL-TR-2123

November 1999

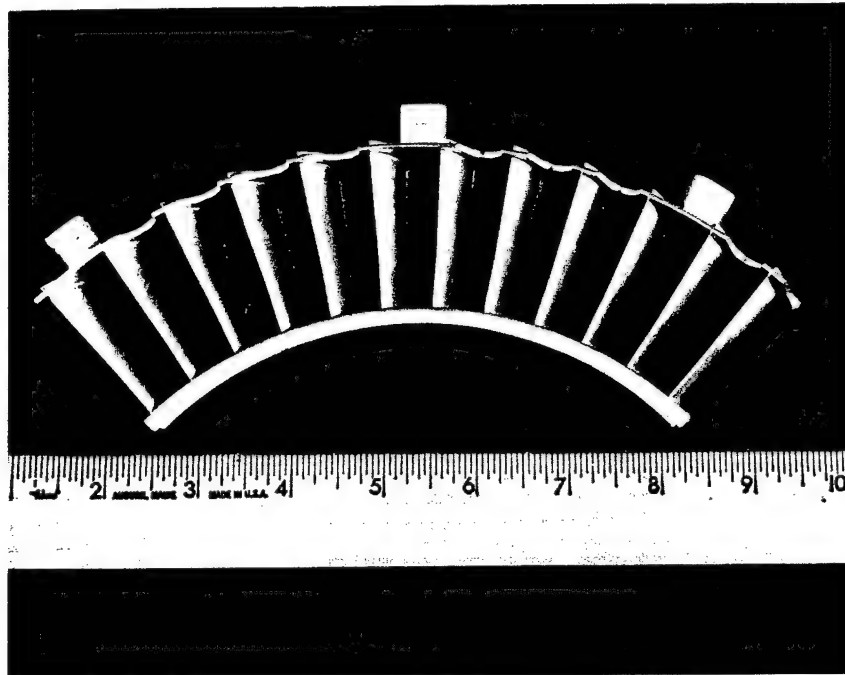
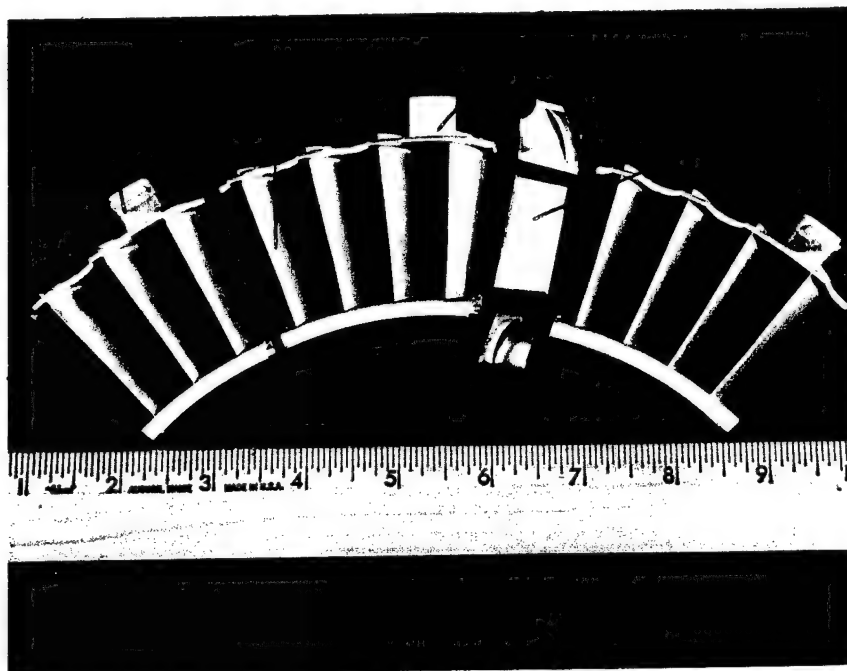
3.1 Sectioning. The sixth stage engine compressor stator vane assembly is governed by Avco Corporation's Drawing Package 2-100-060-26 [1]. Figures 1 and 2 depict the stator vane assembly initially sectioned in half. Figure 2 shows the additional dissection of the component for examination and testing. Portions of the individual vanes were needed for bend and

Figure 1. Sectioned Half of the Stator Vane Assembly (Reduced Approximately 0.75×).

Figure 2. Additional Dissection of the Stator Vane (Reduced Approximately 0.75×).

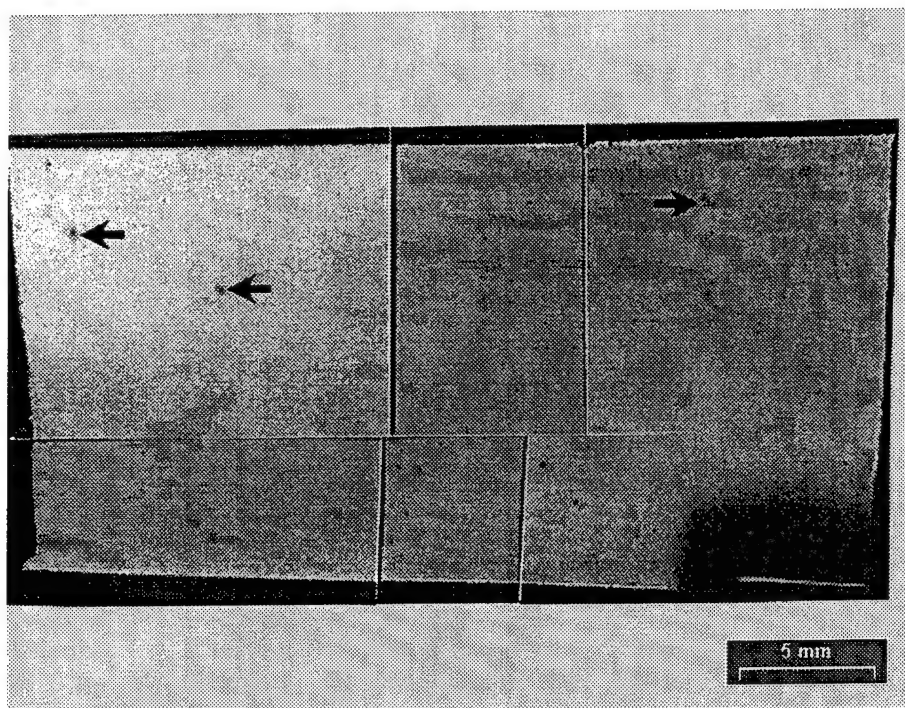
The previous findings obviously constituted failure of the visual requirements stipulated by AMS 2400 Rev. S [2]. The corrosion observed on the as-received components was indicative of a coating system that was not capable of providing protection under normal environmental conditions. It was readily apparent that this coating system would not be adequate to pass the engine corrosion test requirement, an environment much more severe than our standard atmosphere.

Figure 3. Concave Side of a Single Vane Showing Corrosion Pits.

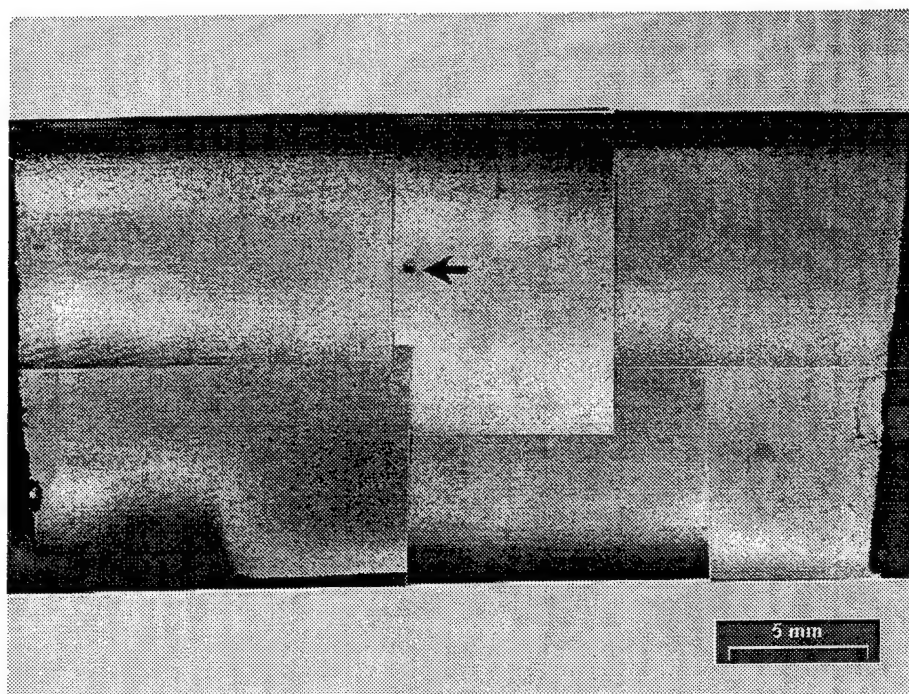
Figure 4. Convex Side of a Single Vane Showing Corrosion Pits.

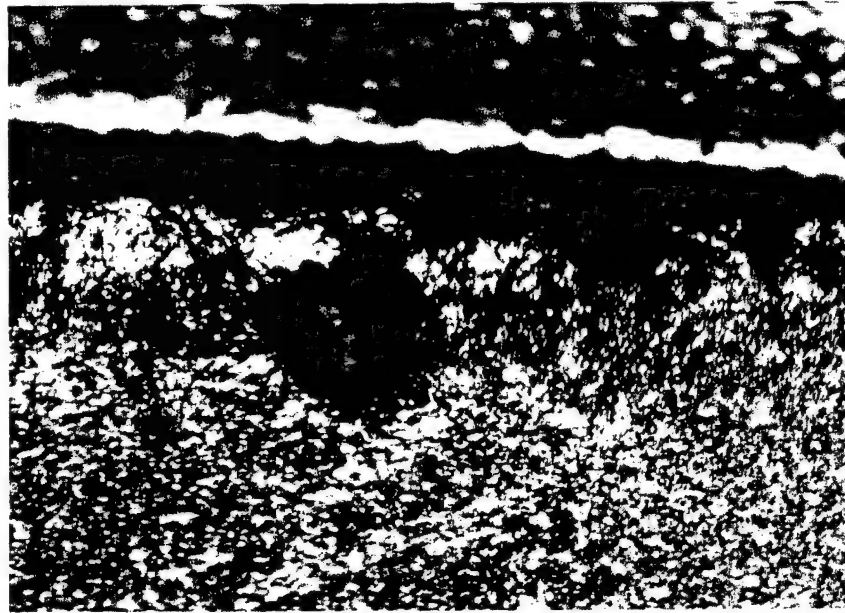
Figure 5 depicts a typical "black spot" at higher magnification. White product can be seen inside this particular "black spot," which is more clearly defined as a corrosion pit. The areas where the vanes were brazed to the inner shroud contained what appeared to be corrosion stains. It is within these stains where pitting was predominant, as shown in Figure 6. The characteristic bronze or iridescent yellow hue of a chromic acid sealer was not observed. However, it should be noted that a thinner coating would result in a clear chromic acid coating.

Figure 5. Typical Corrosion Pit Found on the Stator Vane Assembly (Magnified 65×).

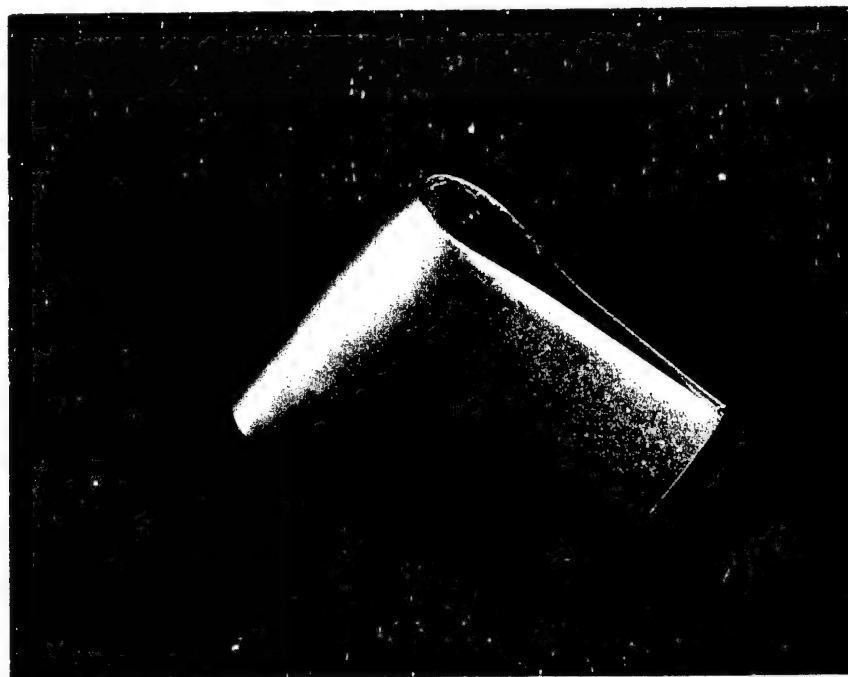
specimens shall not show separation of the plating from the basis metal, when examined at 4× magnification, after being bent rapidly, in accordance with ASTM-E-290, through an angle of 180° around a mandrel with a diameter equal to the thickness of the specimen [2, 3]. A single vane was carefully sectioned from the interior and exterior shroud of the assembly. The sectioned vane was then bent around a mandrel with a diameter approximately equal to the thickness of the vane. The bent vane can be observed in Figure 7. No evidence of failure was noted.

Figure 7. ARL Vane Bend Test Specimen (Magnified Approximately 3×).

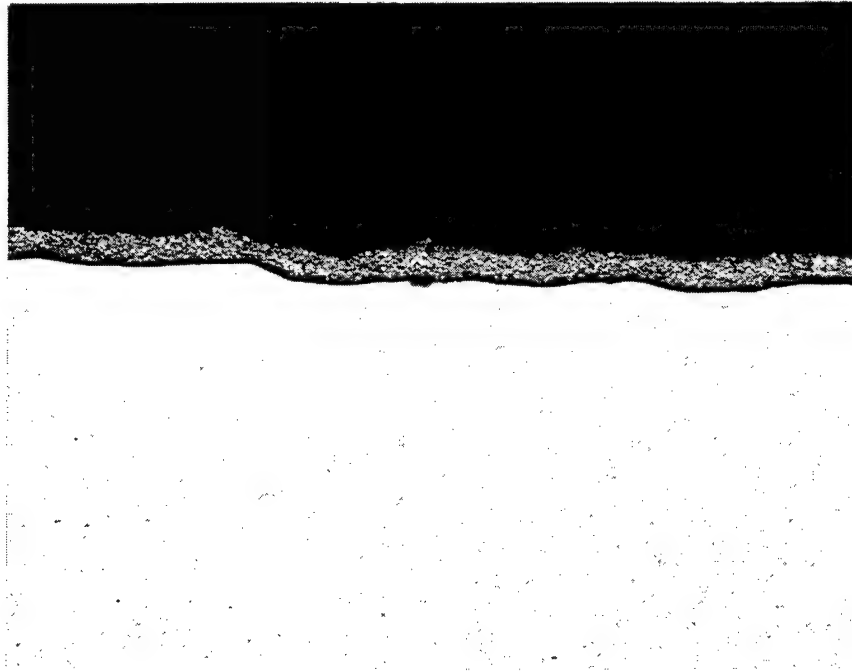
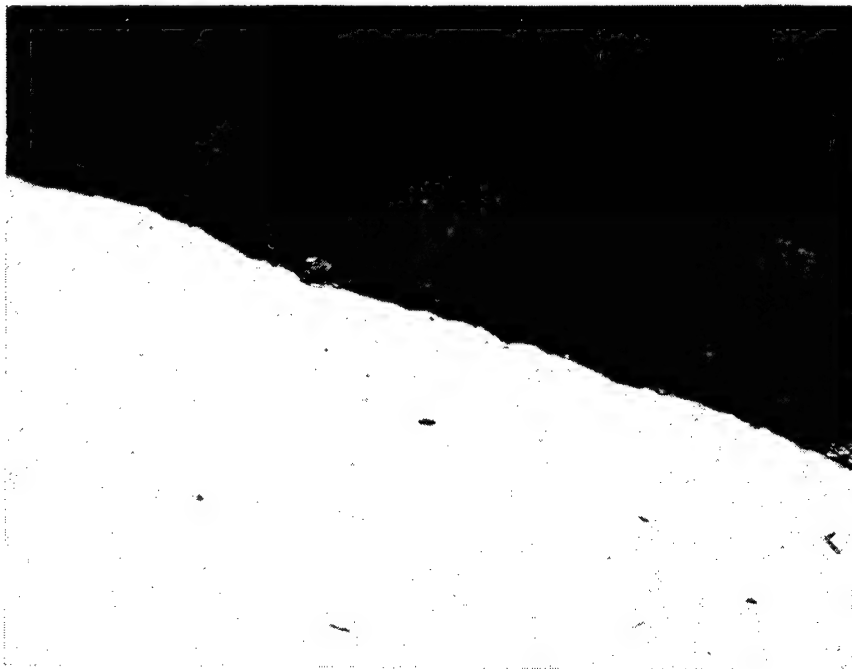
3.5 Coating Thickness. These components were designated to have a 2400-3 coating system, according to AMS 2400 Rev. S [2]. Table 1 of AMS 2400 Rev. S lists the thickness requirement for designation 2400-3 as 0.0003–0.0005 in, with the only exception being that this only applies to areas that can be touched by a 0.75-in-diameter sphere, as established in section 3.4.1.4 [2]. Cross-sections of several vanes were prepared metallographically and examined per ASTM-B-487 [5]. Figure 11 shows a representative area along the convex side of a vane near the inner shroud where the cadmium plating was approximately 0.0003 in thick. In contrast, Figure 12 is indicative of the nonuniform cadmium plating observed on much of the concave side of a vane near the inner shroud. In this area there is only a hint of plating evident, which would account for the poor corrosion resistance.

Figure 11. Cadmium Plating Thickness on the Convex Side of the Vane (Magnified 500×).

Figure 12. Cadmium Plating Thickness on the Concave Side of the Vane (Magnified 500×).

Realistically, a sphere with a diameter of 0.75 in cannot touch these areas due to the fact that they are near corners. These figures are presented only to represent the variation in coating thickness and to provide a reason why these components performed so poorly under corrosion resistance testing. Conversely, Figures 13 and 14 represent the middle sections of a single stator vane where they could be touched by a 0.75-in-diameter sphere and, therefore, should have a minimum cadmium thickness of 0.0003 in.

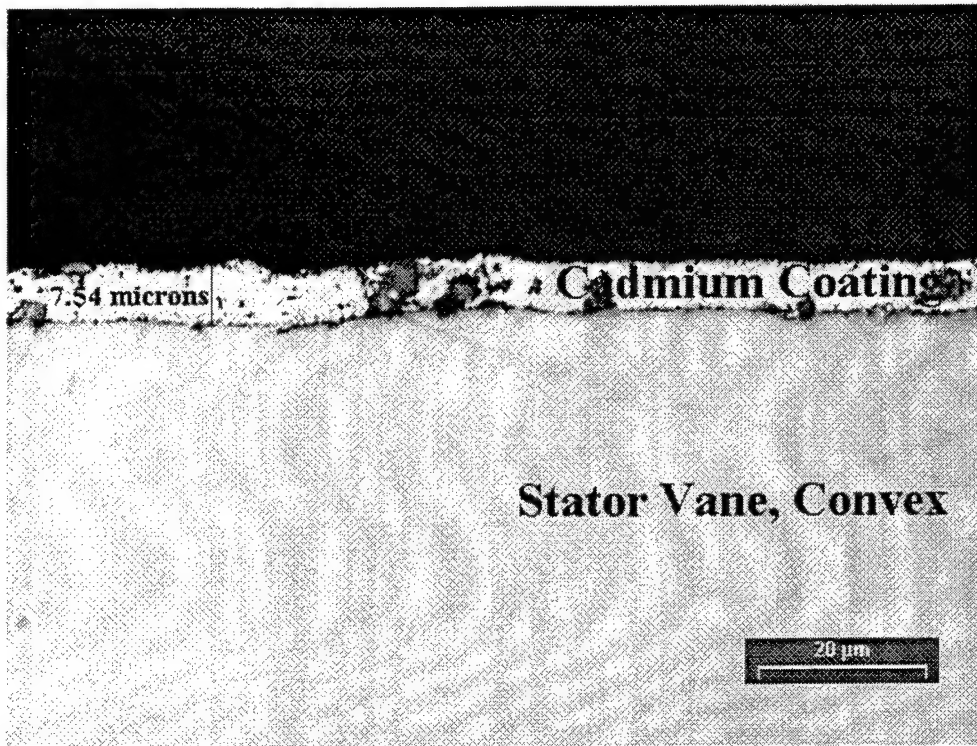
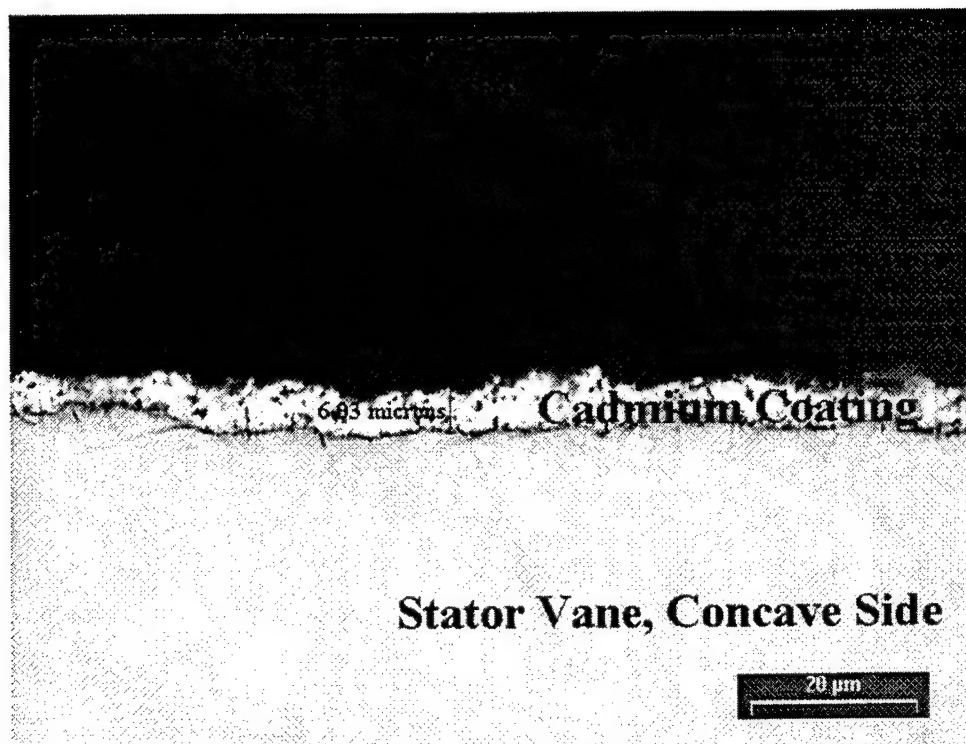
Figure 13. Typical Plating Thickness on the Convex Side of the Vane.

Measurements were taken in several locations along the components. The results show that the coating was thin in most locations but especially near the inner shroud where corrosion was abundant after the 200-hr salt fog test. Table 1 presents the cadmium thickness measurements, including the locations, taken on the part.

Figure 14. Typical Plating Thickness on the Concave Side of the Vane.

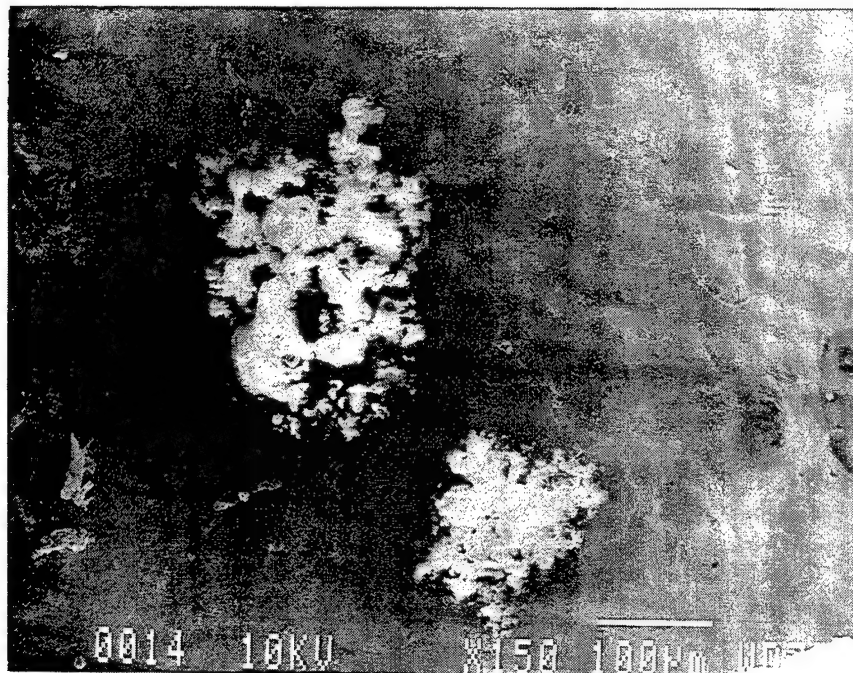
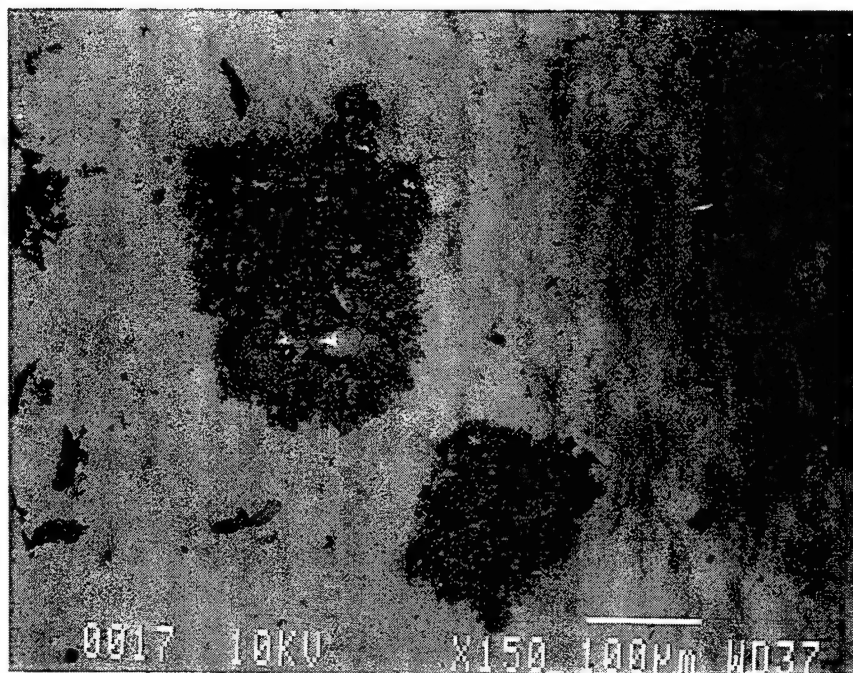
dark areas of corrosion were verified to be pits containing a significant amount of corrosion product. A cadmium plating was detectable on all surfaces; however, in some instances, base metal elements were also detectable, indicating a thin or discontinuous coating. Figures 15 and 16 show the corrosion product within the pits in both secondary and backscatter electron imaging, respectively.

Figure 15. Secondary Electron Image of Corrosion Product Within a Pit (Magnified 150×).

Figure 16. Backscatter Electron Image of the Product Within a Pit (Magnified 150×).

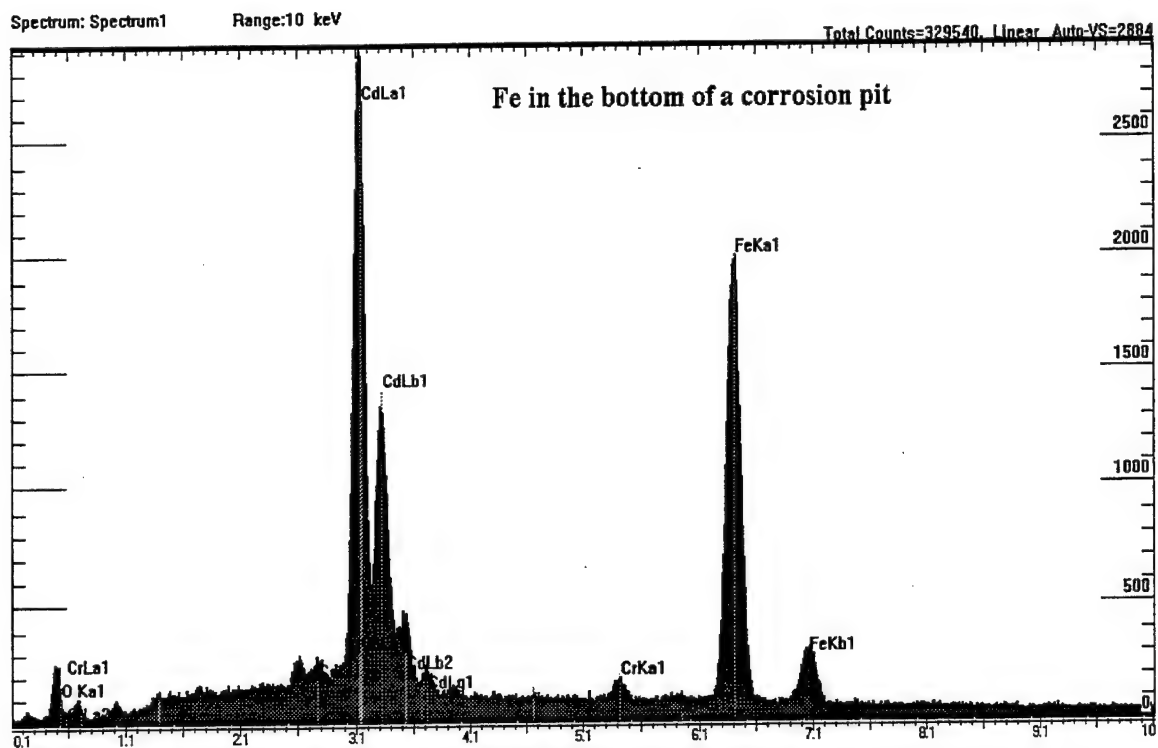
These corrosion pits were found to extend to the base metal as evidenced by the Fe peak in the EDS spectrum. This is depicted in Figure 17.

Figure 17. EDS Spectrum Showing Iron Within the Corrosion Pit.

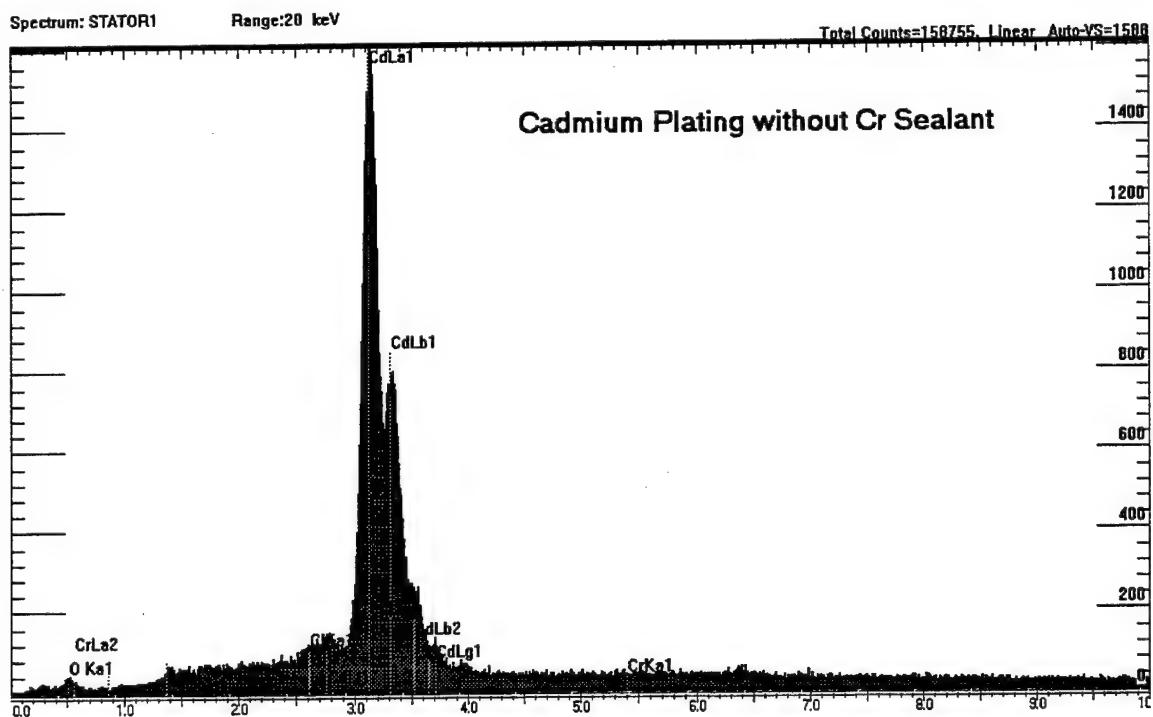
Specification AMS 2400 Rev. S stipulates that the cadmium must be sealed with a chromic acid sealant or with a chromate or phosphate treatment when specifically approved [2]. An attempt was made to verify the existence of a chromium or phosphorus sealer over the cadmium coating. These sealers would be evidenced by the presence of the elements Cr or P, respectively, within the EDS spectrum. Neither element was observed above the scatter within the EDS spectrum. Figure 18 presents the EDS spectrum from a representative stator vane. The only elements observable in Figure 18 are oxygen (O) and cadmium (Cd). To further investigate, a cadmium-plated nut known to have a chromate sealer was analyzed and indeed was found to contain a significant amount of the element Cr within, or on top of, the cadmium coating. Figure 19 presents the EDS spectrum showing the Cr peak. These findings suggest that either the sealer was absent or below detectable limits. In either case, the corrosion protection afforded would be minimized.

Figure 18. EDS Spectrum Displaying the Absence of Cr on the Stator Vane.

the EDS spectrum, as previously discussed. The element was not observed above the background of the EDS spectrum. Figure 18 depicts a similar EDS spectrum showing the absence of chromium over cadmium plating. Typically, chromated and chromic-acid-treated components do contain measurable amounts of Cr. These findings show either the sealer was absent or below detectable limits. In either case, the corrosion protection afforded would be minimized. This minimal protection was demonstrated under salt fog exposure. The old section with 2.33% chromic acid treatment nearly outperformed the recoated section that had almost twice the cadmium coating thickness and no detectable chromate or chromic acid treatment.

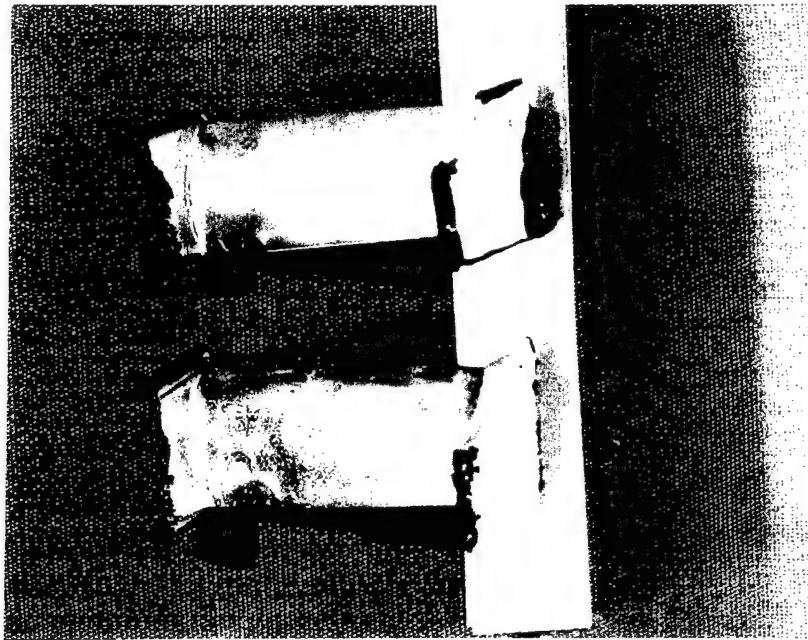
contrasted with the dull gray previous coating in Figure 24. Figures 25–27 depict a section of the old stator after 2.33% chromic acid immersion, where the yellow tint can clearly be observed.

Figure 24. Previous 0.42% Dipped and New Stator Sections (Magnified 1.5×).

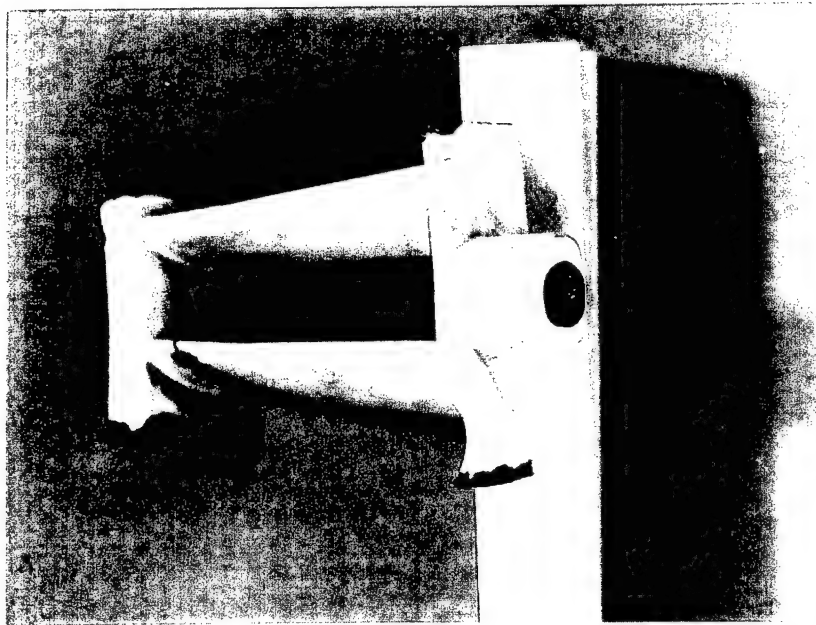
Figure 25. Previous 2.33% Dipped Stator Section, Concave Side (Magnified 1.5×).

Figure 26. Previous 2.33% Dipped Stator Section, Convex Side (Magnified 1.5×).

Figure 27. Previous 2.33% Dipped Stator Section, Braze Area (Magnified 1.5×).

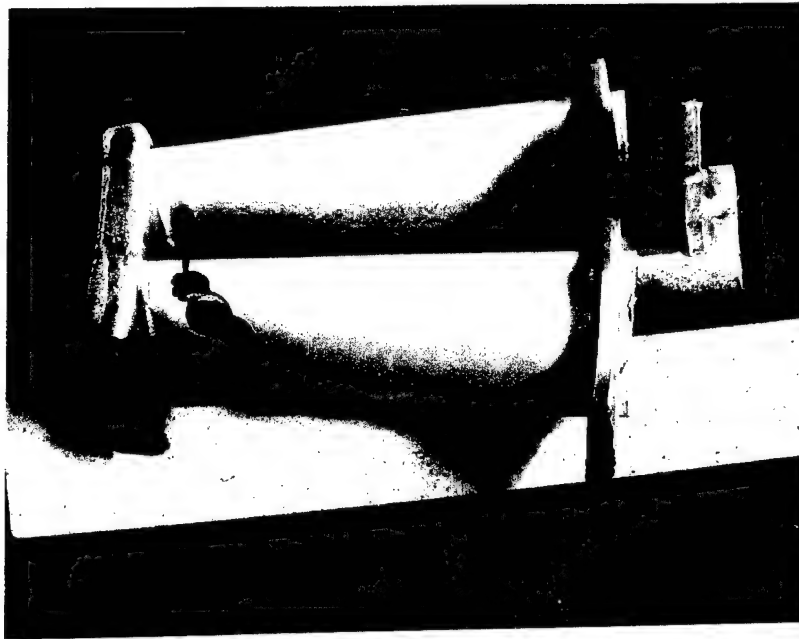
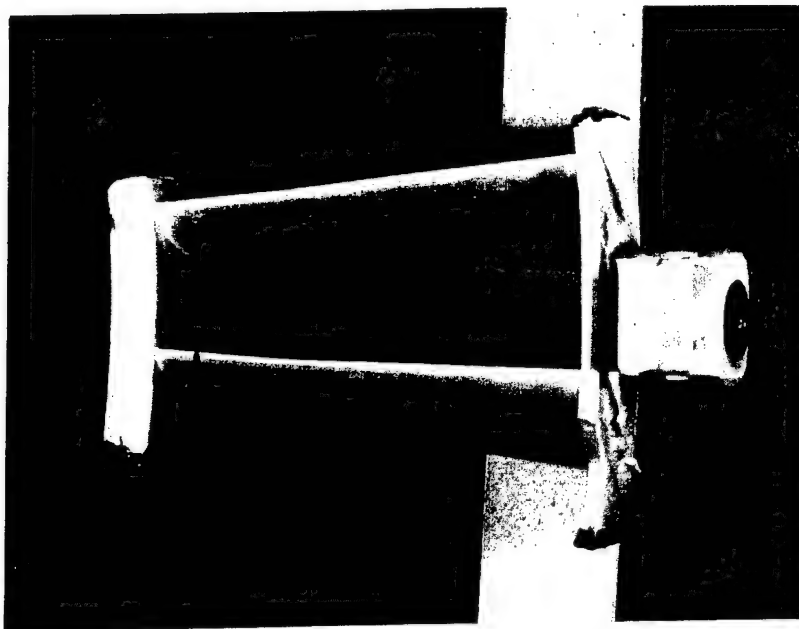
Figure 32 compares the new and old (0.42% dipped) stator sections showing the inner shroud braze area. Both stator sections show only some white cadmium oxide product. No reddish-orange corrosion of the steel is present. Figures 33–35 show that the old (2.33% dipped) stator shows no significant corrosion at all, after 24 hr salt fog exposure.

Figure 33. 2.33% Dipped Stator After 24 hr Salt Fog Exposure, Concave Side (Magnified 1.5 \times).

Figure 34. 2.33% Dipped Stator After 24 hr Salt Fog Exposure, Convex Side (Magnified 1.5×).

Figure 35. 2.33% Dipped Stator After 24 hr Salt Fog Exposure, Braze Area (Magnified 1.5×).

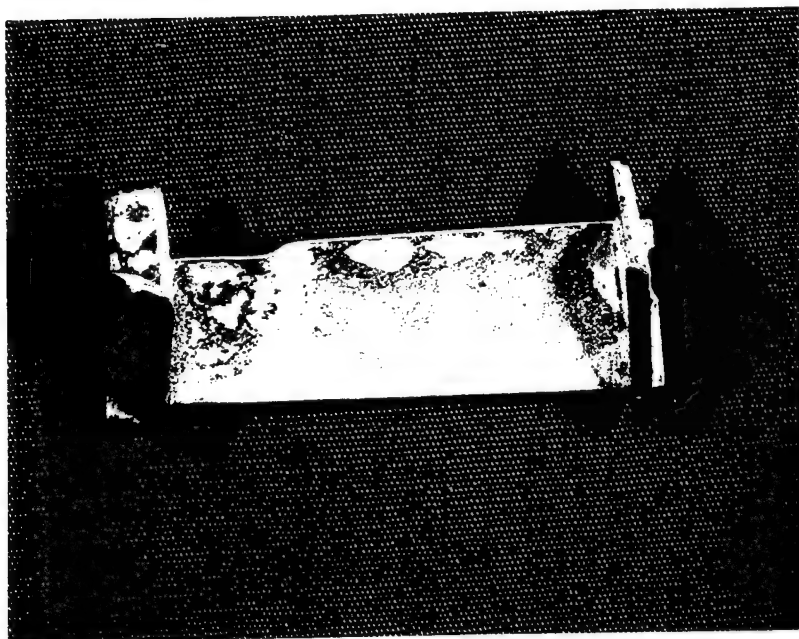
After 200 hr exposure per ASTM-B-117, the new stator exhibited significant white product along the vane and severe pitting within the braze area, as shown in Figures 36 and 37. Figures 38 and 39 depict the corrosive action on the 0.42% dipped old stator and general corrosion can be observed. This general corrosion was more representative of the previous results obtained. However, the area of corrosion seemed to be limited to the inner shroud braze area. Comparative macrographs of the new stator vs. the old 0.42% dipped stator are shown in Figures 40 and 41. After 200 hr of exposure, general corrosion of the 0.42% dipped stator was observable near the inner shroud brazed area and pitting was observable on the new corrosion system stator. It could not be determined which corrosion-resistant coating performed better. Neither would pass the corrosion requirements established in AMS 2400 Rev. S [2].

Figure 36. New Stator Section After 200 hr Salt Fog Exposure, Concave Side (Magnified 1.5 \times).

Figure 37. New Stator Section After 200 hr Salt Fog Exposure, Convex Side (Magnified 1.5 \times).

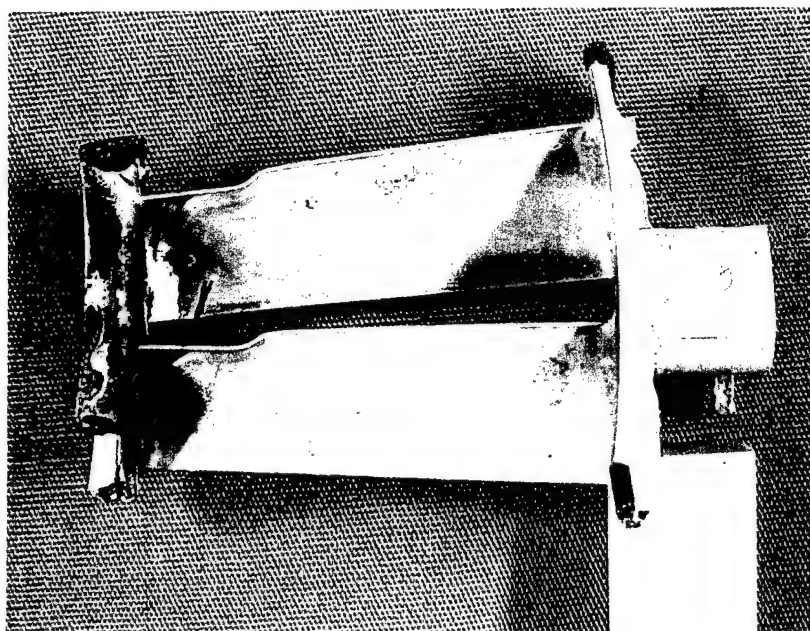
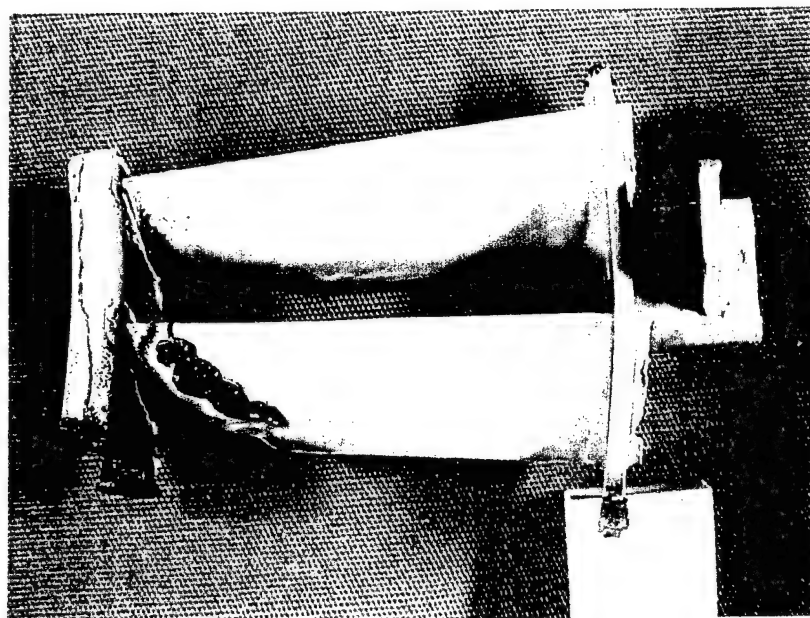
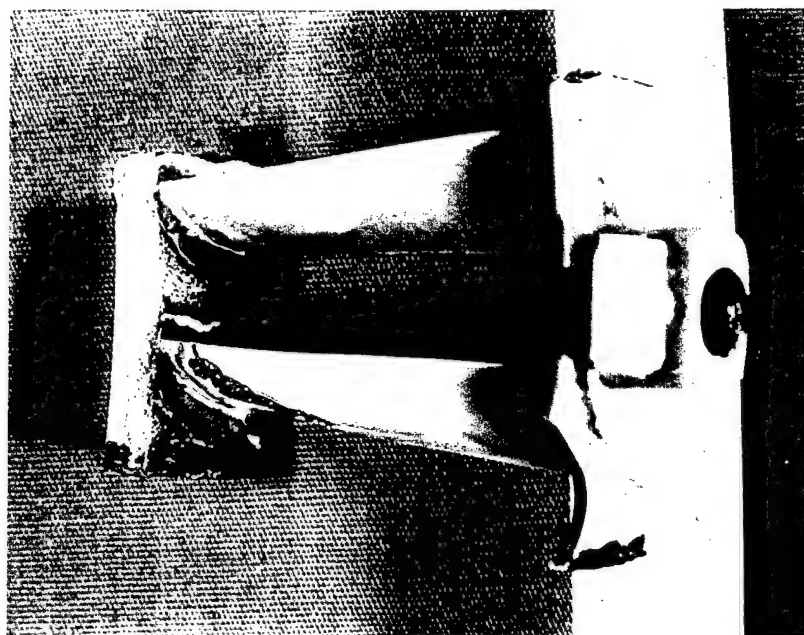
Figures 42–44 depict the 2.33% dipped old stator after 200 hr of salt fog exposure per ASTM-B-117. Some slight corrosion was evident along the braze and inner shroud. However, this section appeared to completely inhibit the white cadmium oxide product from forming and looked the best in comparison to the other sections.

Figure 42. 2.33% Dipped Stator After 200 hr Salt Fog Exposure, Concave Side (Magnified 1.5 \times).

Figure 43. 2.33% Dipped Stator After 200 hr Salt Fog Exposure, Convex Side (Magnified 1.5 \times).

Figure 44. 2.33% Dipped Stator After 200 hr Salt Fog Exposure, Braze Area (Magnified 1.5 \times).

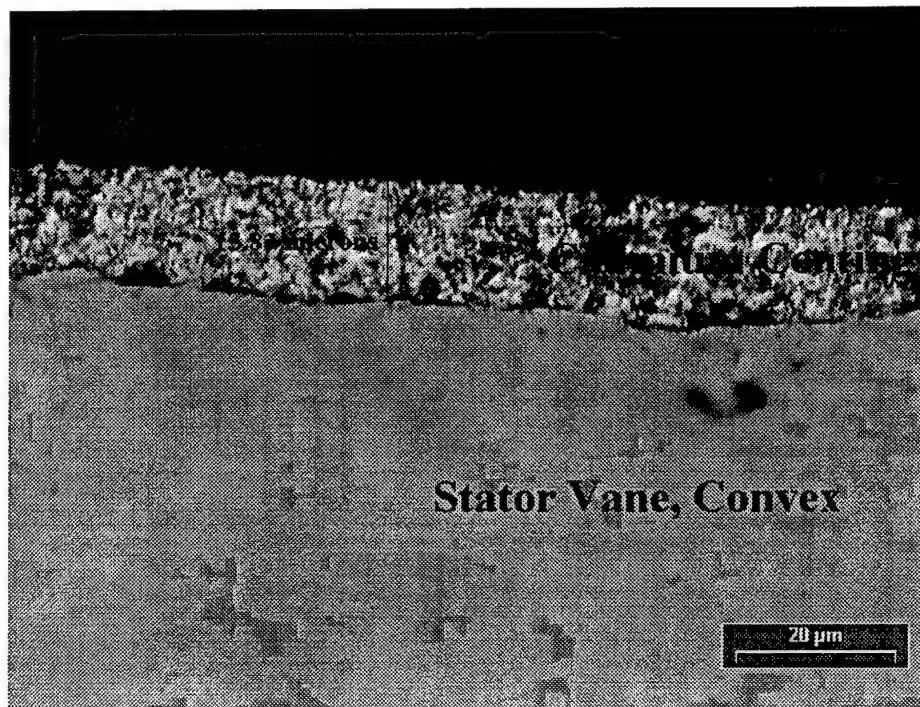
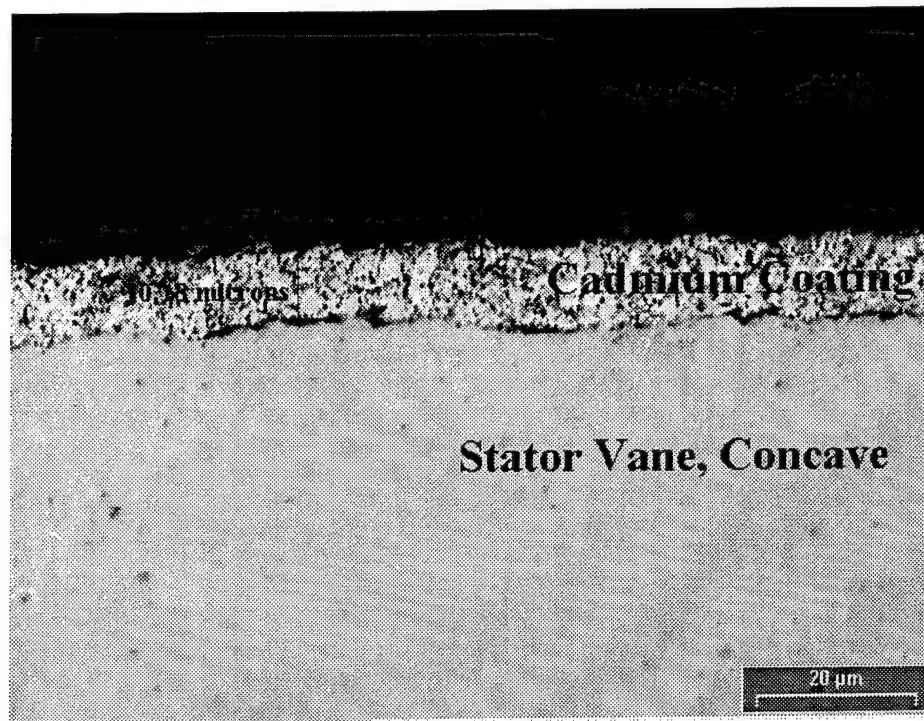
4.2 Coating Thickness. Similar cross sections of several vanes were prepared metallographically and examined per ASTM-B-487, as previously discussed [5]. Figure 48 shows a representative area along the convex side of a vane near the inner shroud where the cadmium plating was approximately 0.00065 in thick. In contrast, Figure 49 is indicative of the

Figure 48. Cadmium Plating Thickness of New Stator Near Inner Shroud, Convex Side.

Figure 49. Cadmium Plating Thickness of New Stator Near Inner Shroud, Concave Side.

cadmium plating observed on much of the concave side of a vane near the inner shroud where the thickness was approximately 0.00043 in.

The results showed that the cadmium coating thickness was adequate in all locations. In general, the cadmium was approximately twice the thickness of the original part, indicative of a change in the cadmium plating process. This would also account for the vast increase in performance under salt fog exposure, even though the component still failed according to the governing requirement. Table 2 presents the cadmium thickness measurements, including the locations taken on the part (contrast the measurements presented in Table 1).

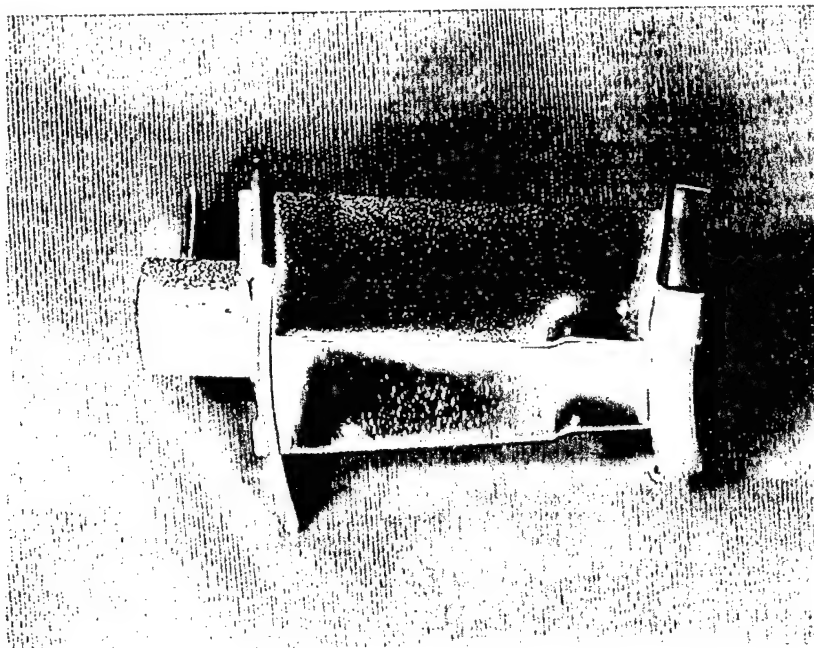
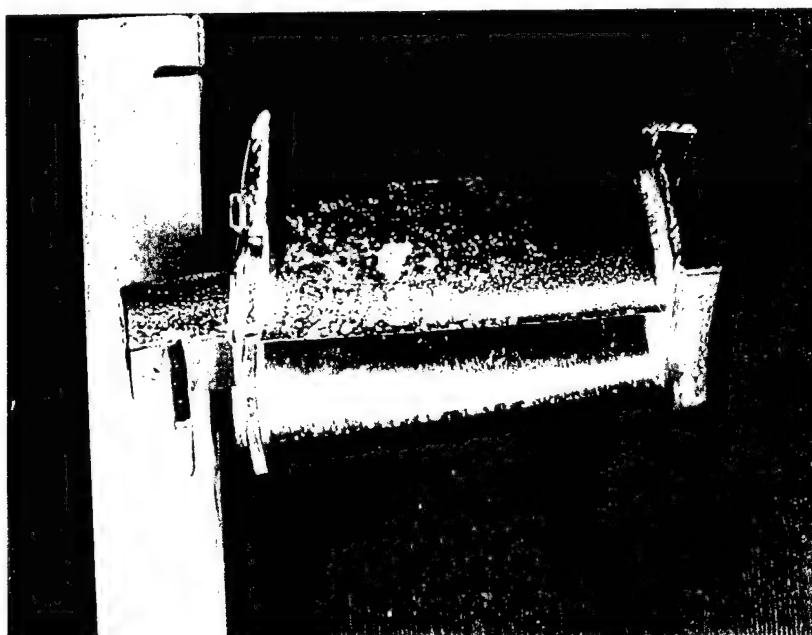
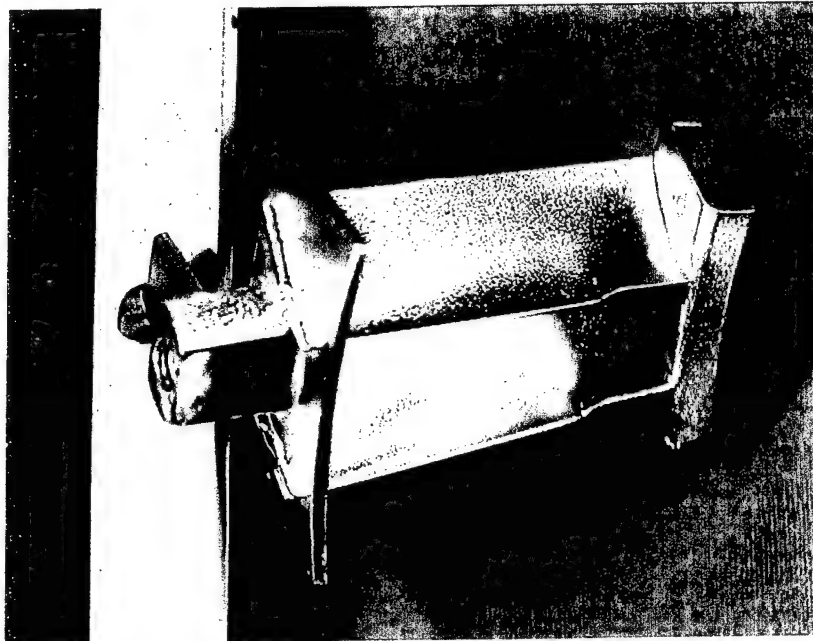
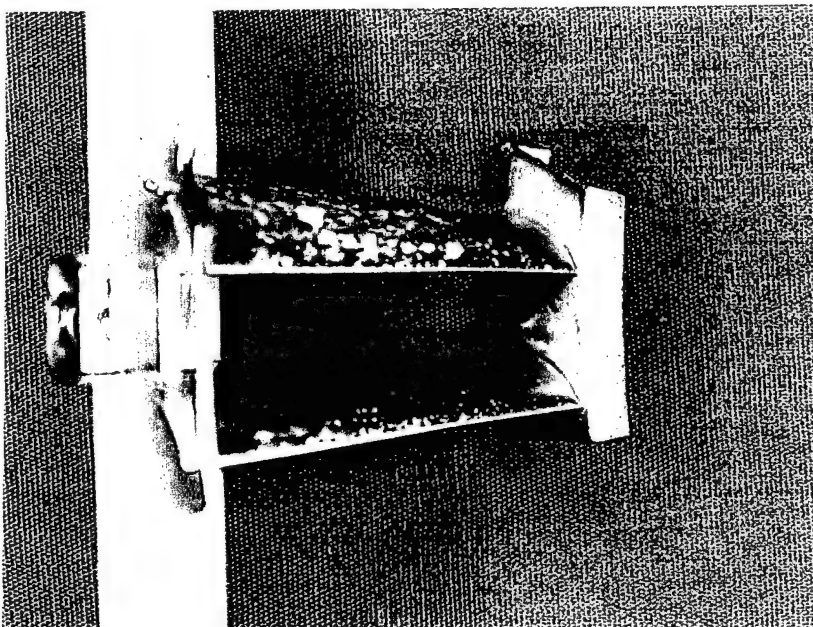
After 200 hr exposure, the new stator barely exhibited any significant white product along the vane and no pitting within the braze area, as shown in Figures 58–61. Only some small water spots on the convex side of the vane were evident.

Figure 58. 200 hr Salt Fog Exposure of the Stator, Concave Side (Magnified 1.5x).

Figure 59. 200 hr Salt Fog Exposure of the Stator, Convex Side (Magnified 1.5x).

Figure 60. 200 hr Salt Fog Exposure, Braze Area, Concave Side (Magnified 1.5×).

Figure 61. 200 hr Salt Fog Exposure, Braze Area, Convex Side (Magnified 1.5×).

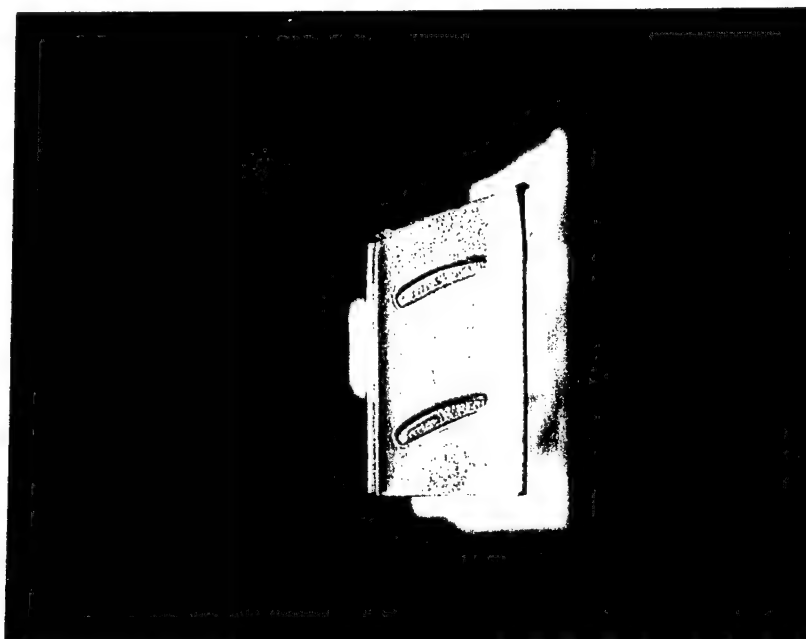
Figure 62 shows the inside edge of the inner shroud where significant corrosion had occurred on previous samples. No corrosion was visible on this stator section. After the 200-hr exposure period, the yellow hue had started to fade but was still evident. The chromic acid treatment appeared to have greatly increased the performance of the components under salt fog exposure testing, as expected. This stator section's corrosion resistance satisfied the requirements of the governing specification.

Figure 62. Inside Edge of Inner Shroud Showing Brazed Vanes (Magnified 1.5×).

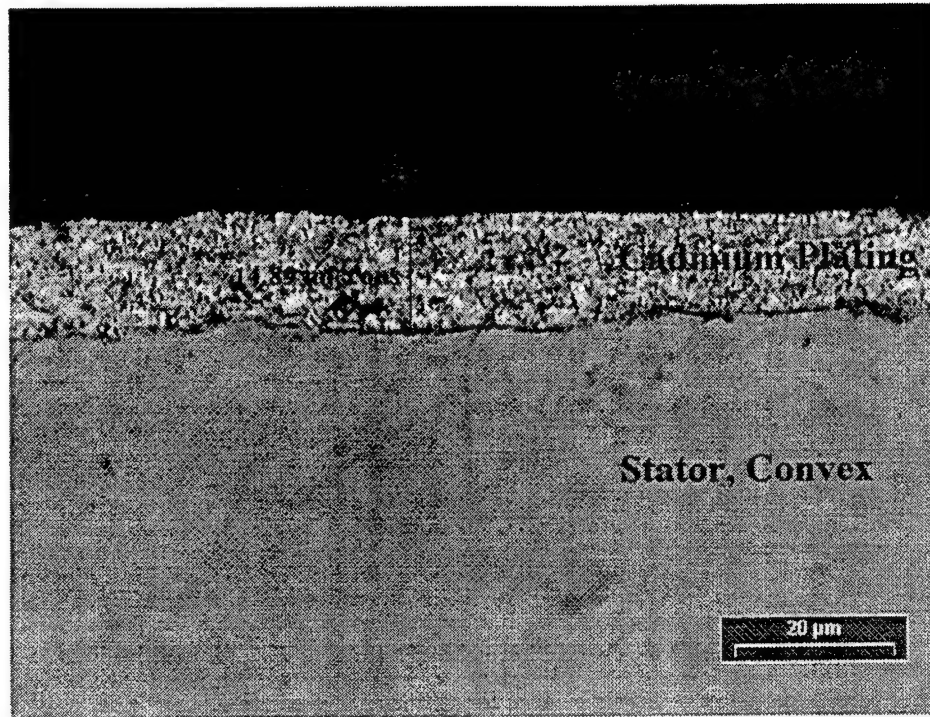
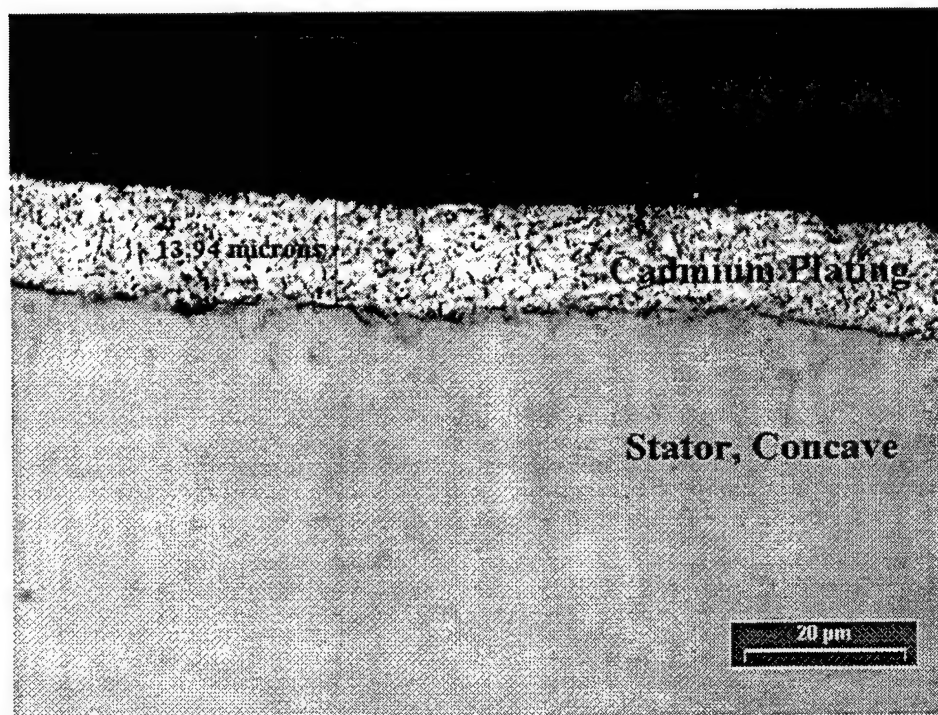
5.4 Coating Thickness. Cross sections of several vanes were prepared metallographically and examined per ASTM-B-487. Figure 64 shows a representative area along the convex side of a vane near the middle where the cadmium plating was approximately 0.00054 in thick. In contrast, Figure 65 is indicative of the cadmium plating observed on much of the concave side of a vane near the middle where the thickness was approximately 0.00043 in.

Figure 64. Cadmium Thickness, Middle of Vane, Convex Side.

Figure 65. Cadmium Thickness, Middle of Vane, Concave Side.

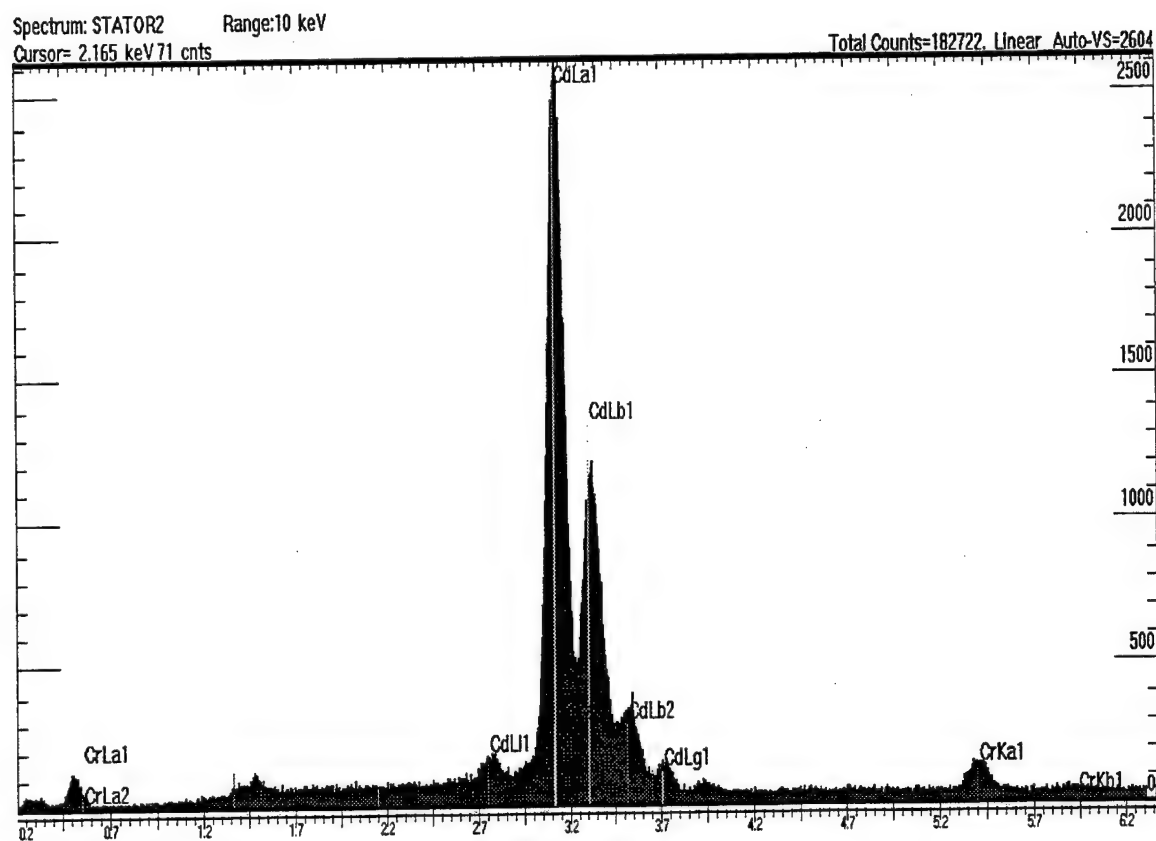
5.5 SEM/EDS Examination. Portions of the sectioned components were examined by SEM. A cadmium plating was detectable on all surfaces. Verification of the existence of a chromate or chromic acid sealer over the cadmium coating was performed with the EDS system. This was evidenced by the presence of the element chromium (Cr) within the EDS spectrum. Figure 66 depicts the EDS spectrum from the new stator vane section.

Figure 66. EDS Spectrum Indicating the Presence of Chromium.
